FREEDOM OF INFORMATION REQUEST

18.	96 – 105	Draft TCCS Technical Note Urbos Frame Cracking	November 2021	Full		Y
19.	106	Email Correspondence	18 November 2021	Full		Y
20.	107-110	Draft Question Time Brief	17 November 2021	Full		Y

22.	111 – 112	Canberra Metro Operations: Sydney LRV Cracking Issues Key Messages	Undated	Full		Y
23.	113 – 122	TCCS Technical Note Urbos Frame Cracking	November 2021	Full		Y

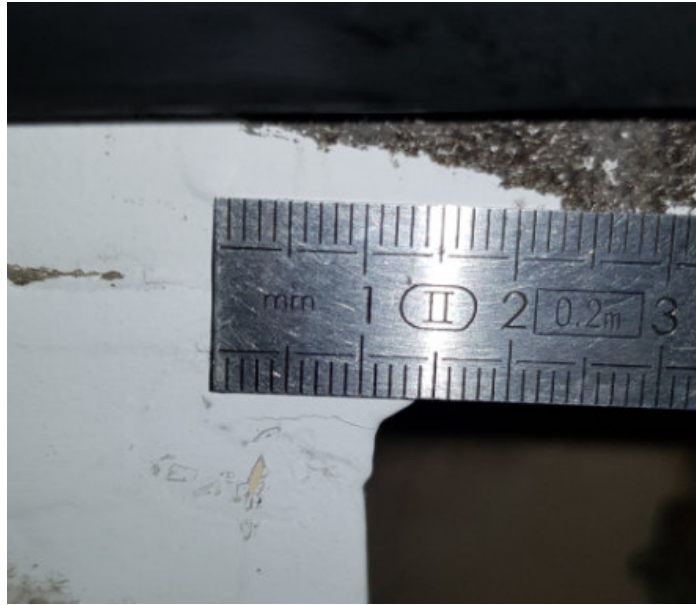
Figure 2 Scenario 1

1. Scenario 1: Crack initiation. Crack length up to 10 mm concentrated at the corner, according to Figure 2.

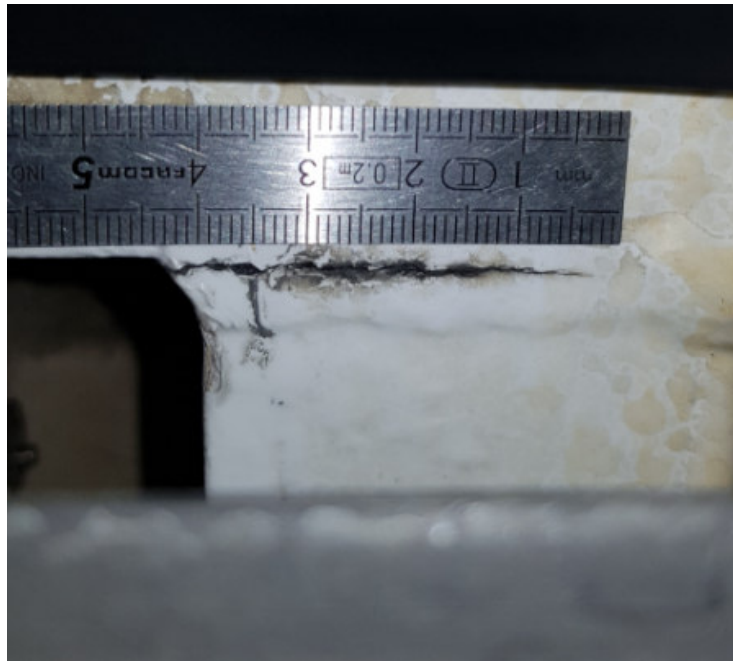
Figure 3 Scenario 2

- Scenario 2: Crack length lower than approx. 50 mm. In those cases, the crack is contained on the weld connecting the webs to seal the door portal with door leaves when these ones are closed, not affecting the vertical weld. See Figure 3

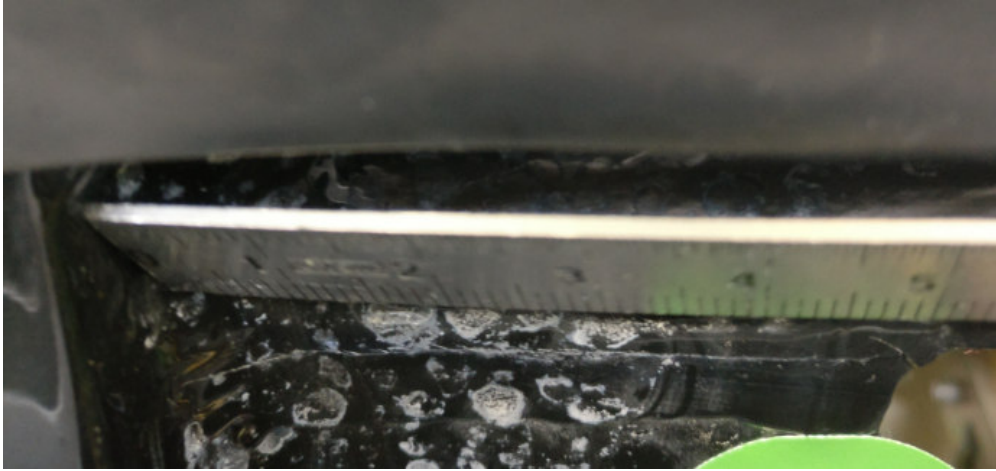
- Scenario 3: Crack length between 50-55 mm. Horizontal weld between webs sealing the door portal have completely failed and crack tip is on the vertical web. See Figure 4

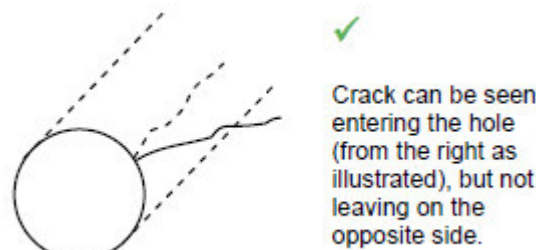
Figure 11 Capture of crack ends

As far as possible, confirm that the crack can be seen entering the hole but not leaving on the opposite side.

If the crack appears to continue beyond the hole, following actions shall be considered:

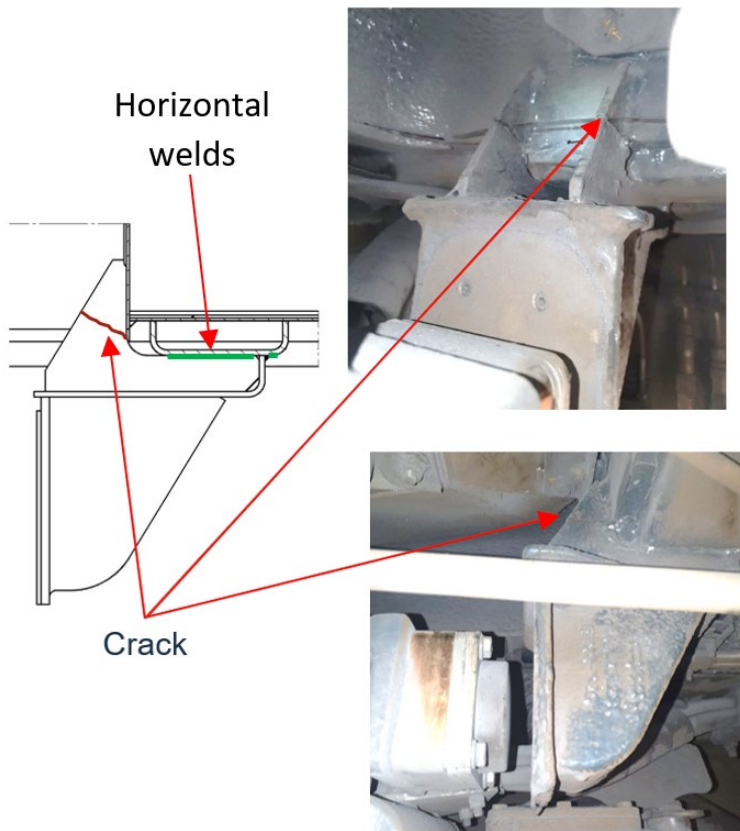
Figure 2: Location of crack on IWLR stiffening web of the bump stop

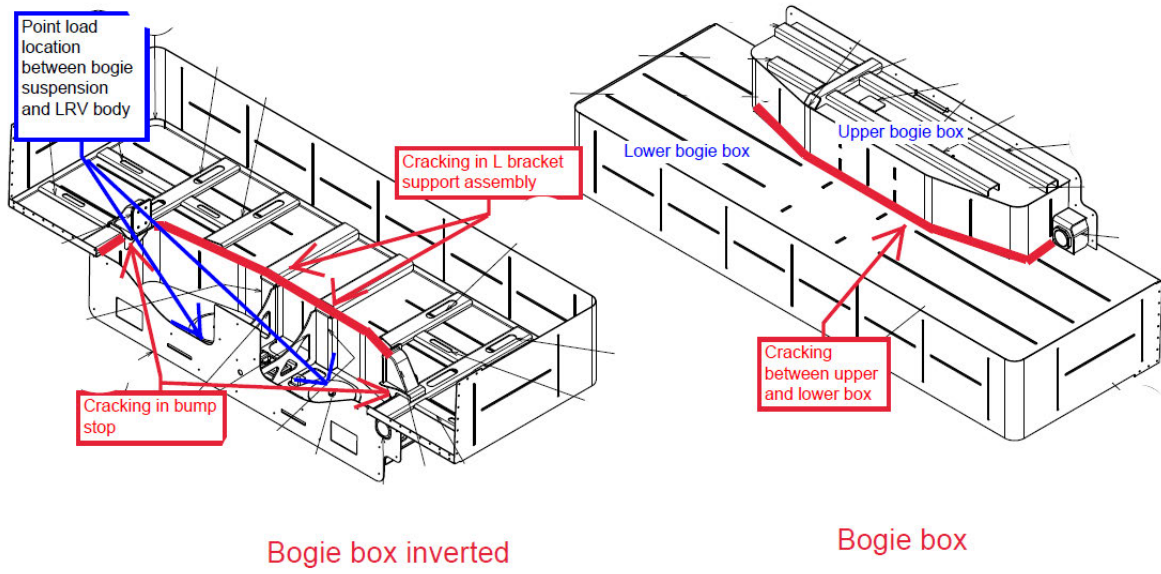
On the 28 October 2021, TfNSW advised that buses would replace light rail services on the IWLR. On 5 November 2021 it was revealed that cracking in the bogie box similar to West Midlands Metro had been found in all 12 LRVs operating on the IWLR system. Investigation into the root cause of the cracking experienced in both the bogie bump stop and the bogie box in Sydney is ongoing and is being monitored by both Canberra Metro and TCLR.

Figure 3: Location of cracks on IWLR Bogie Box

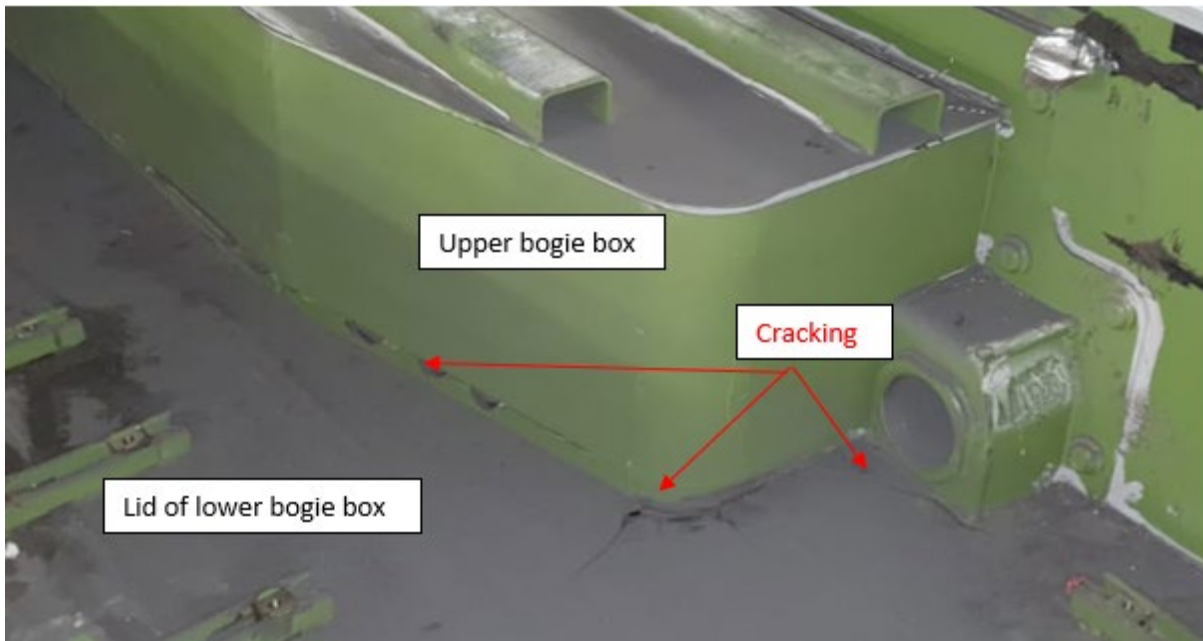
Figure 4: IWLR Cracks between upper and lower bogie boxes visible after removal of seats and floor

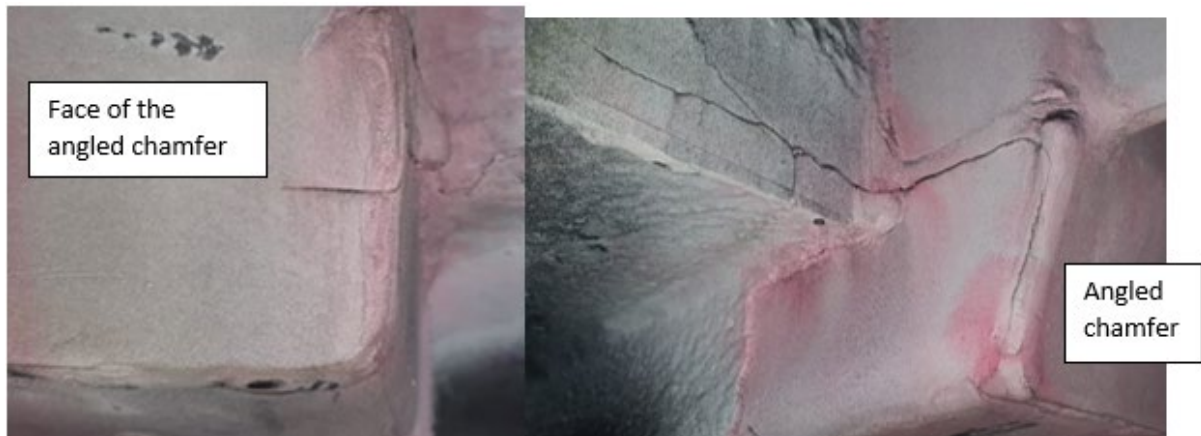
Figure 5: Cracks in L brackets visible after removal of bogie and protective coating (using dye penetrant test)

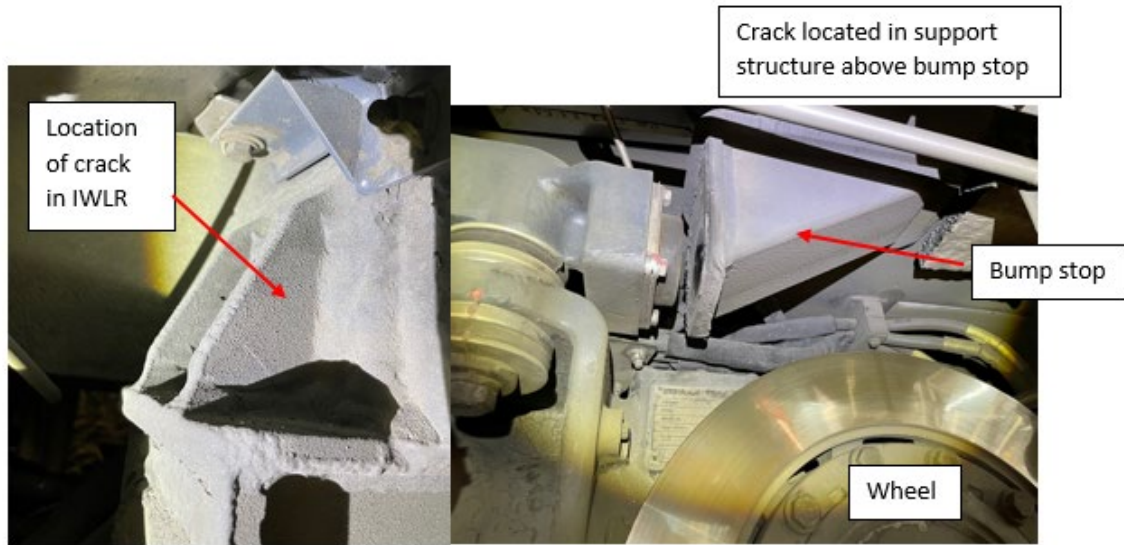
Figure 7: Canberra bump stop on LRV011 showing no signs of cracking.

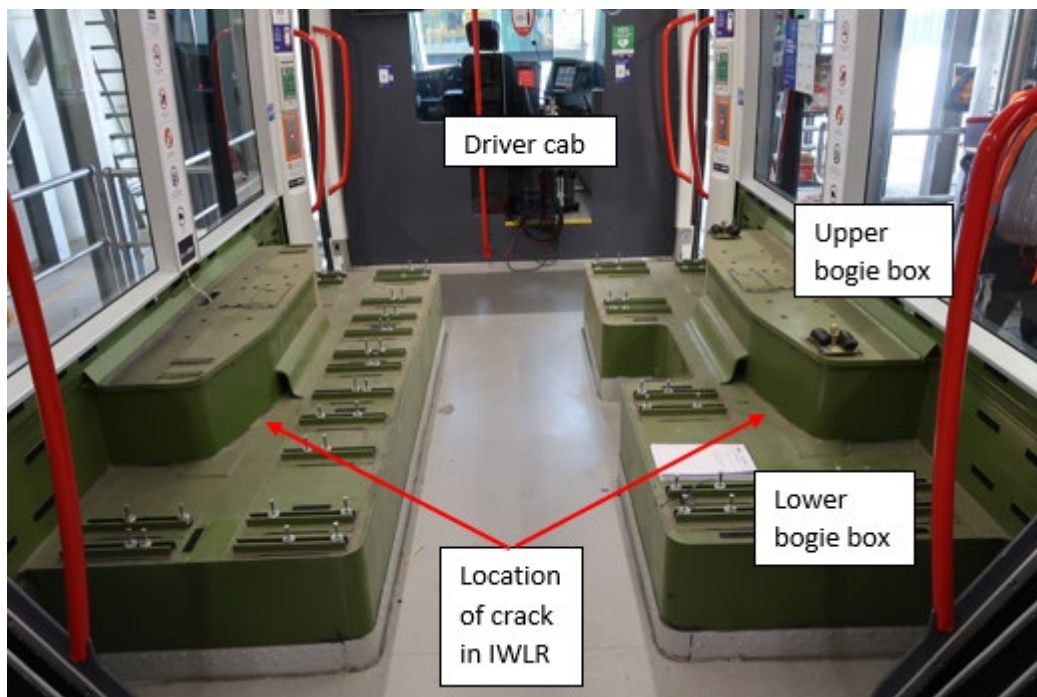
Figure 8: Canberra bogie box on LR011 showing no visible signs of cracking

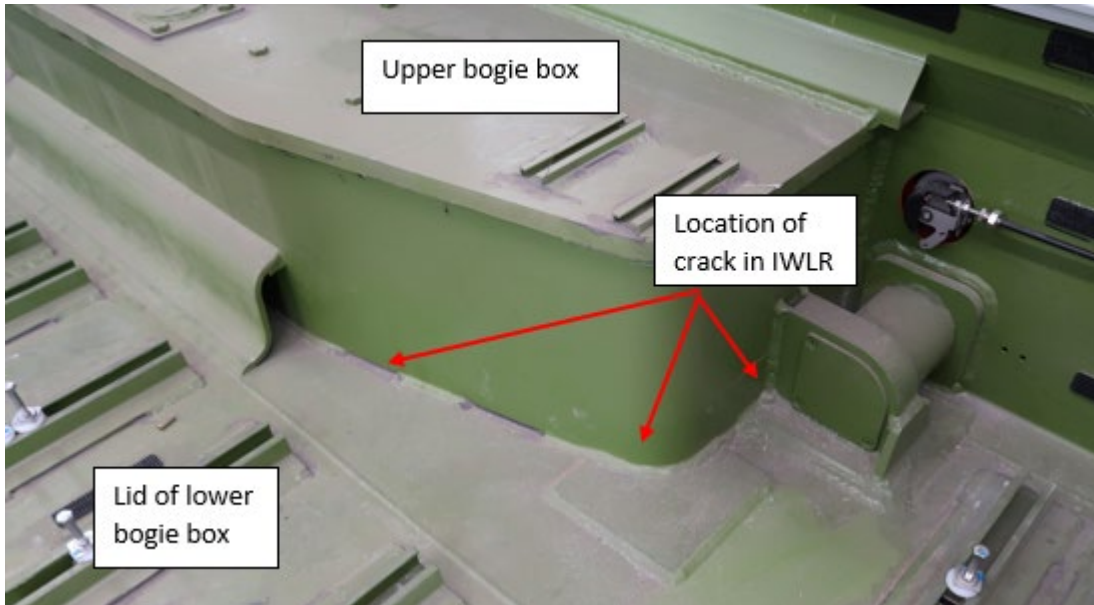
Figure 9: Canberra bogie box on LR011 showing no visible signs of cracking

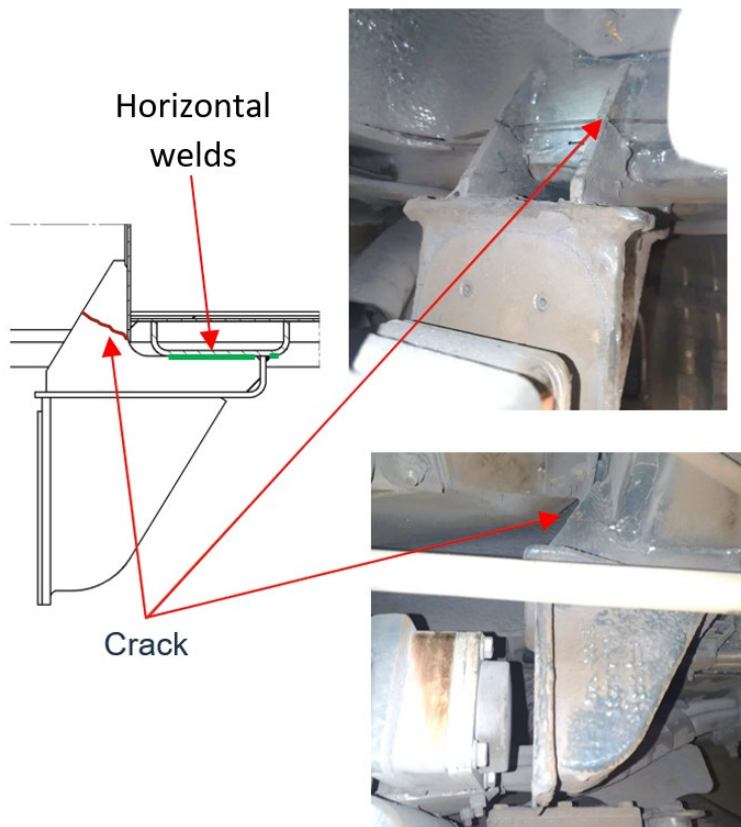
Figure 2: Location of crack on IWLR stiffening web of the bump stop

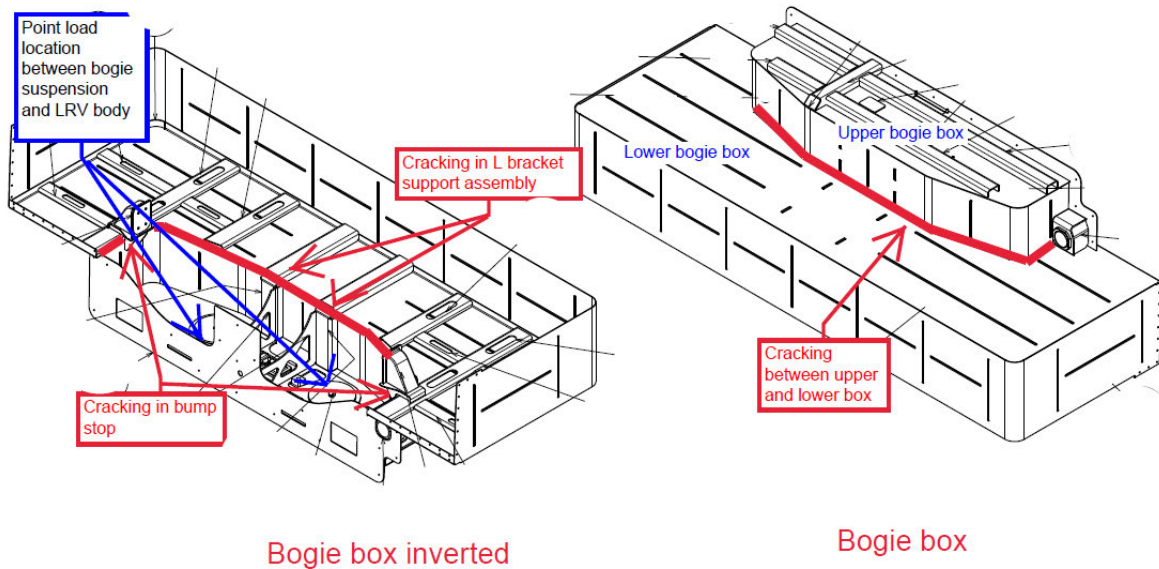
Investigation into the root cause of the cracking experienced in both the bogie bump stop and the bogie box in Sydney is ongoing and is being monitored by both Canberra Metro and TCLR.

Figure 3: Location of cracks on IWLR Bogie Box

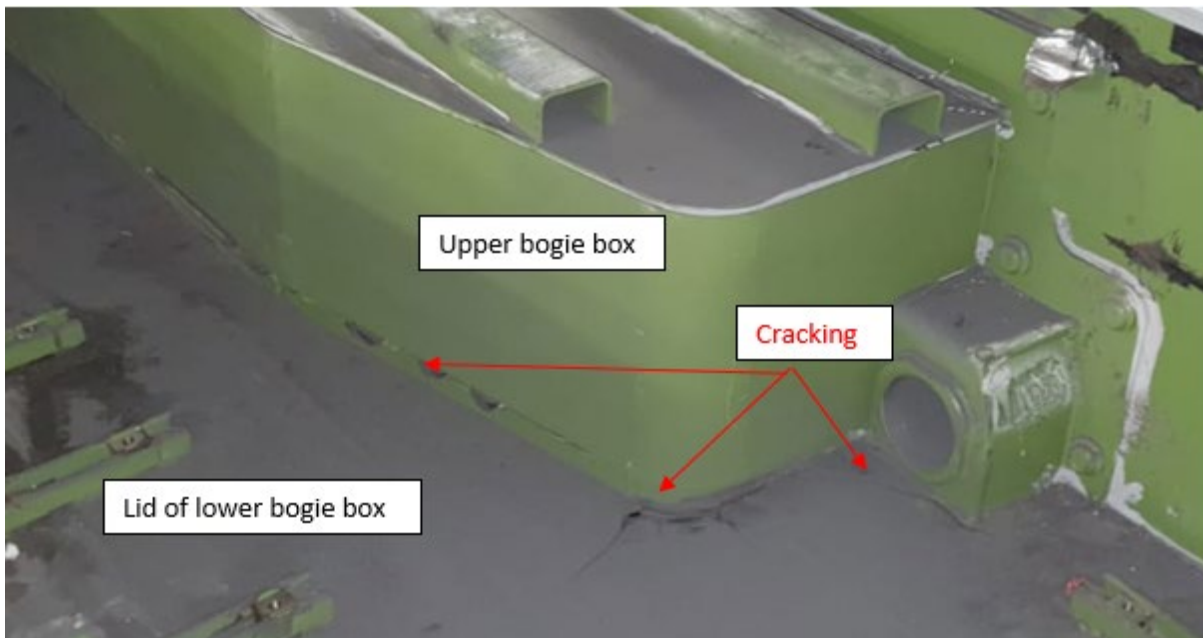
Figure 4: IWLR Cracks between upper and lower bogie boxes visible after removal of seats and floor

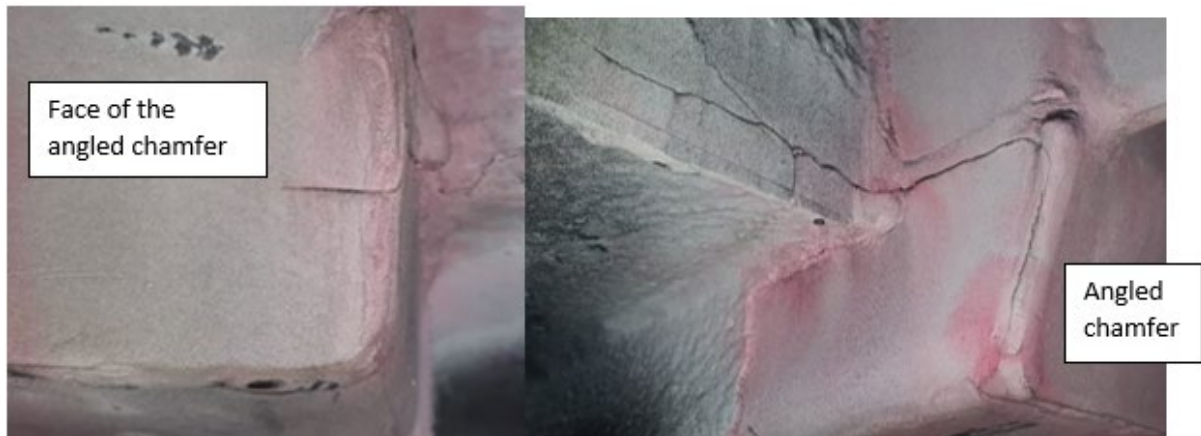
Figure 5: Cracks in L brackets visible after removal of bogie and protective coating (using dye penetrant test)

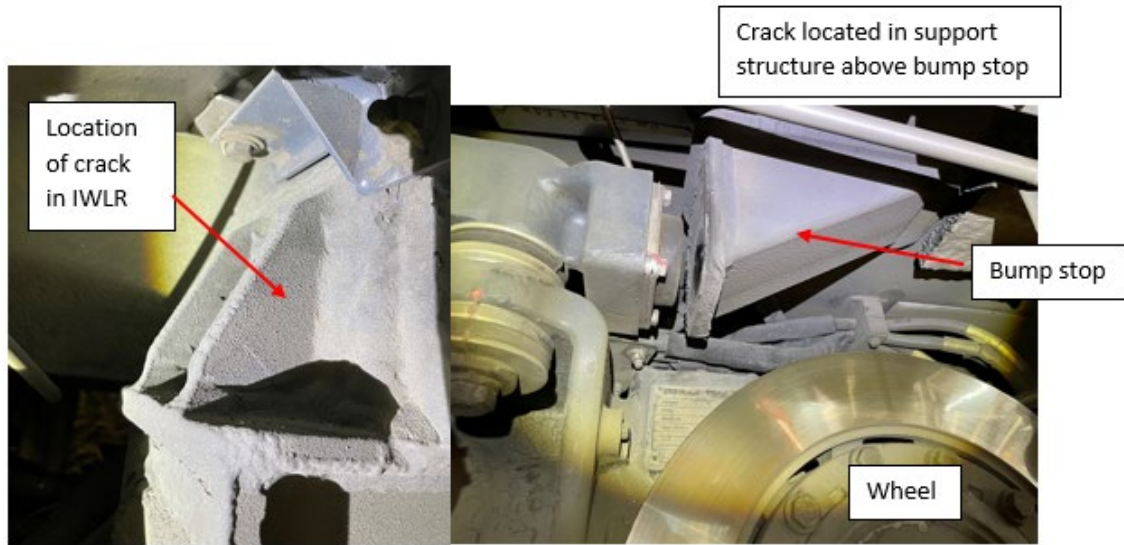
Figure 7: Canberra bump stop on LRV011 showing no signs of cracking.

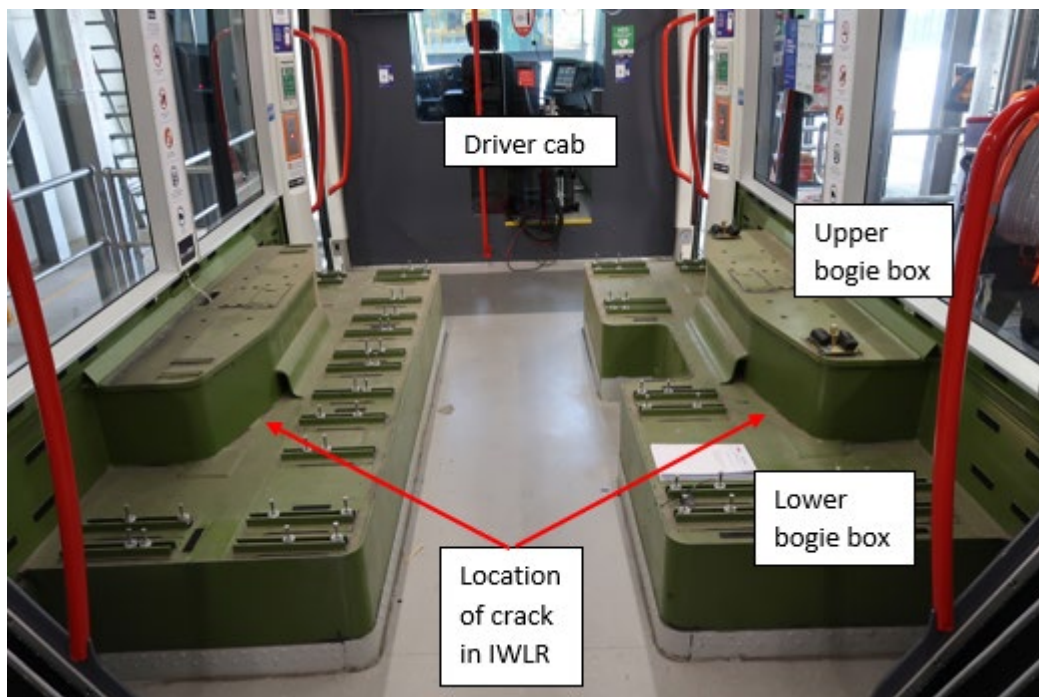
Figure 8: Canberra bogie box on LR011 showing no visible signs of cracking

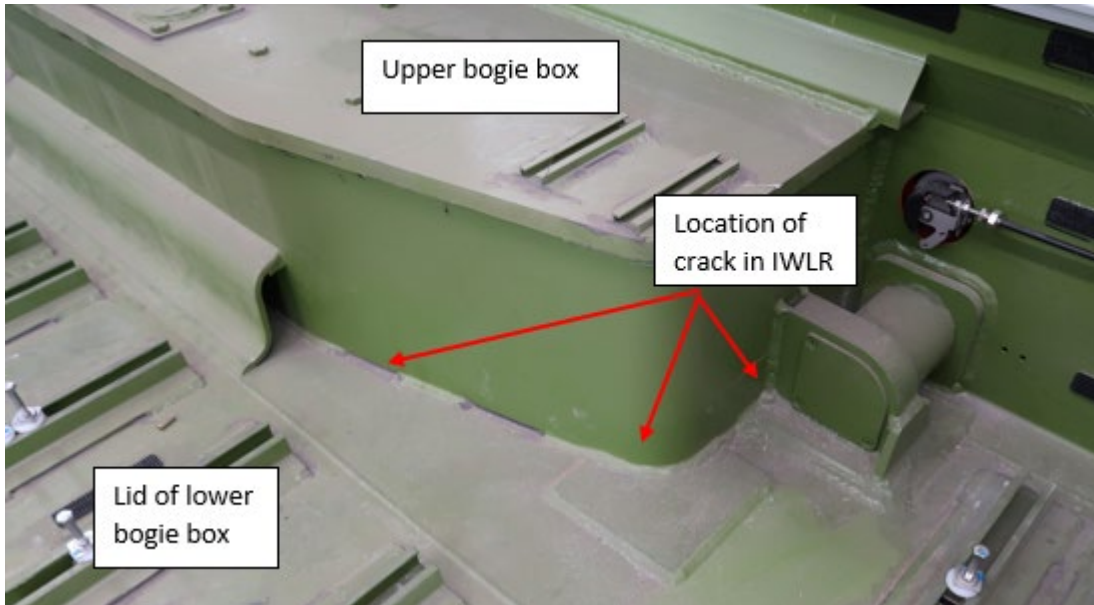
Figure 9: Canberra bogie box on LR011 showing no visible signs of cracking
