Isabella Weir Upgrade Design and Construction Monitoring

Site Investigations Factual and Interpretive Report

Project Number 3002402

Prepared for: ACT Government Shared Services
Procurement
Date: 28-05-15

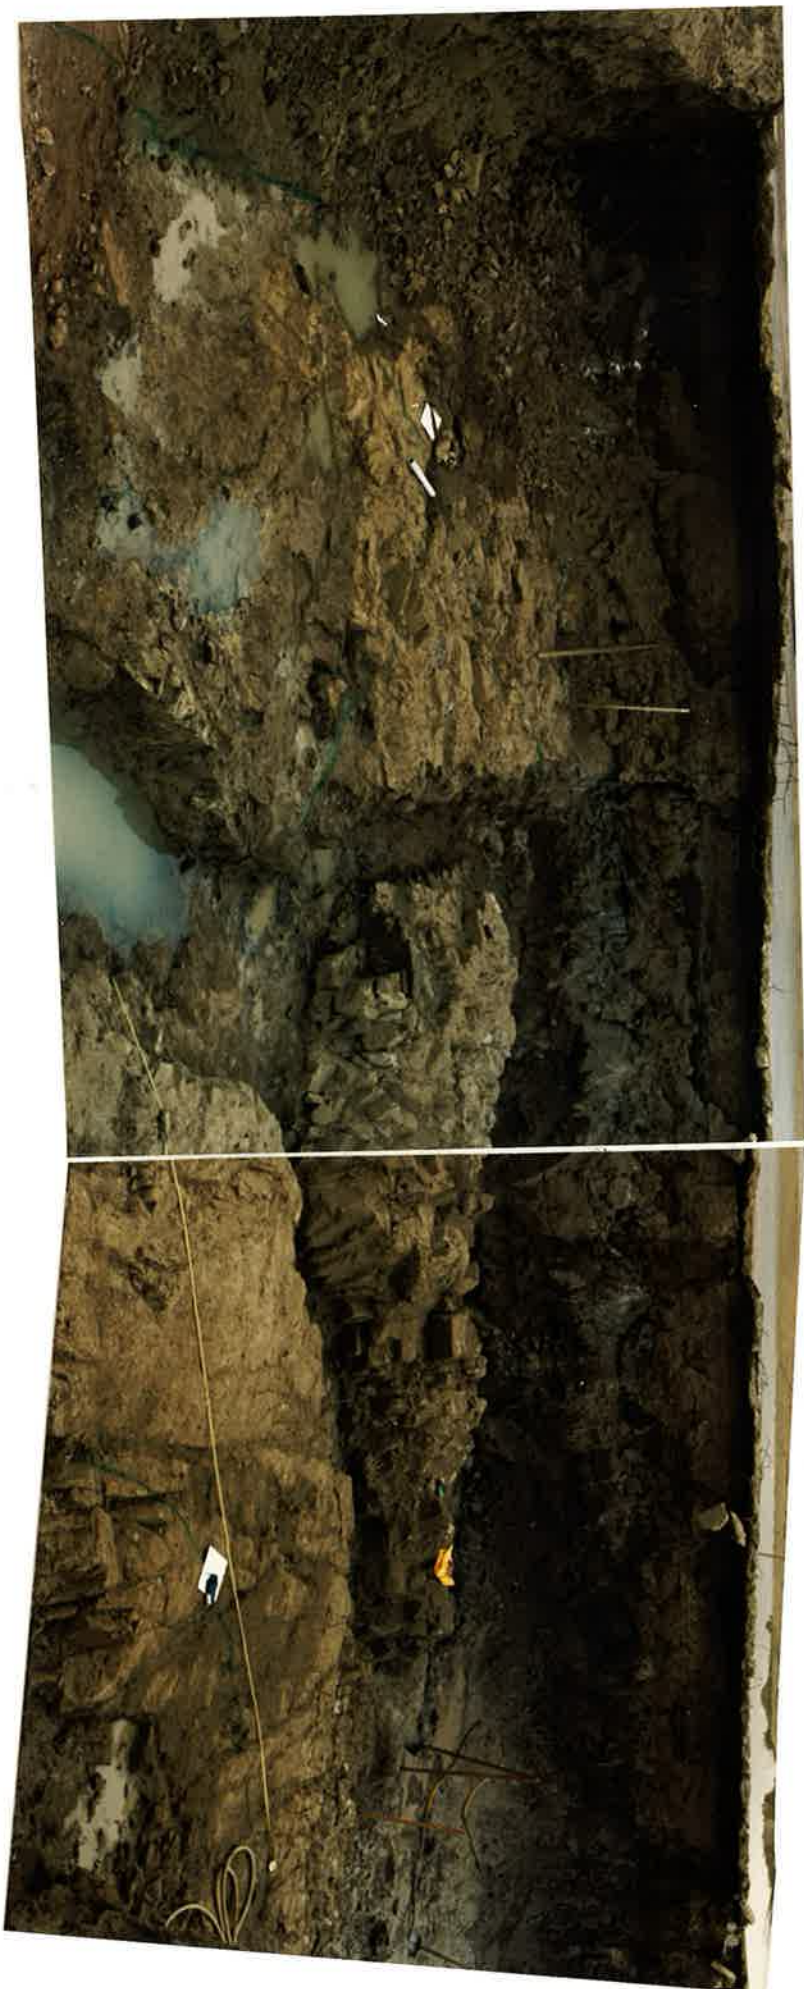
PHOTOGRAPH 1 View from northern abutment, showing clean up of cut-off trench and adjacent foundations. June, 1986

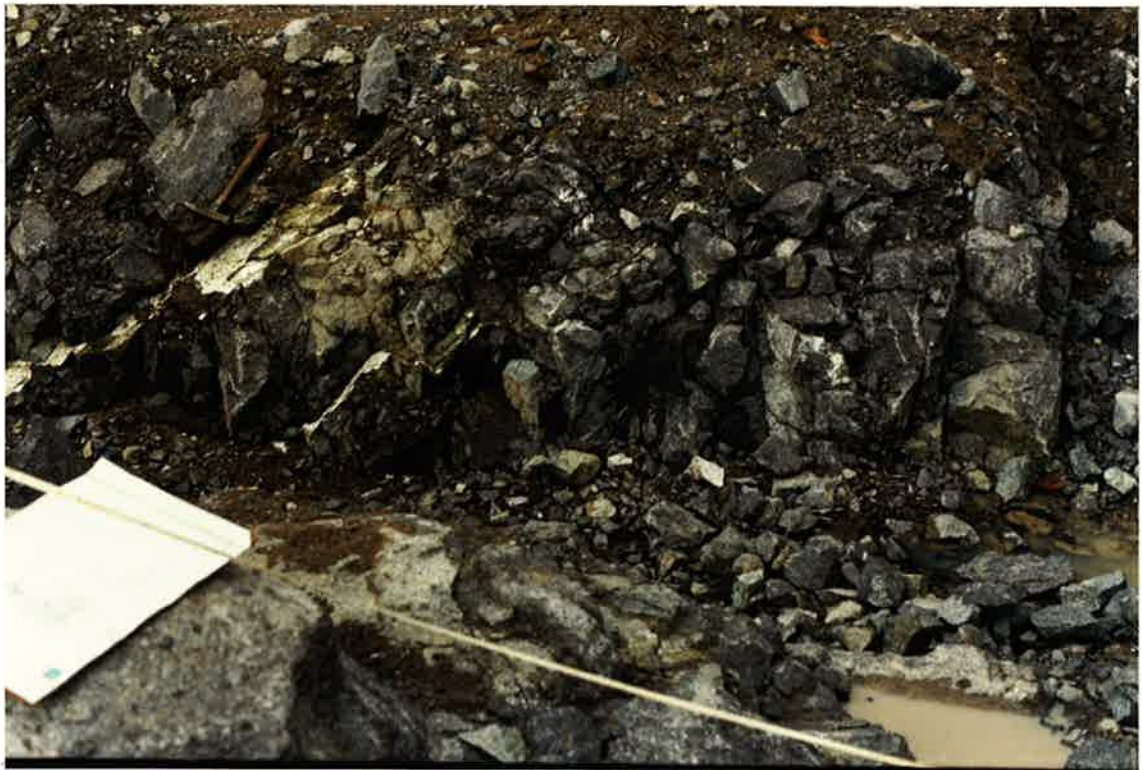
PHOTOGRAPH 11 Central Channel, closely jointed zones in foundation area. February, 1987

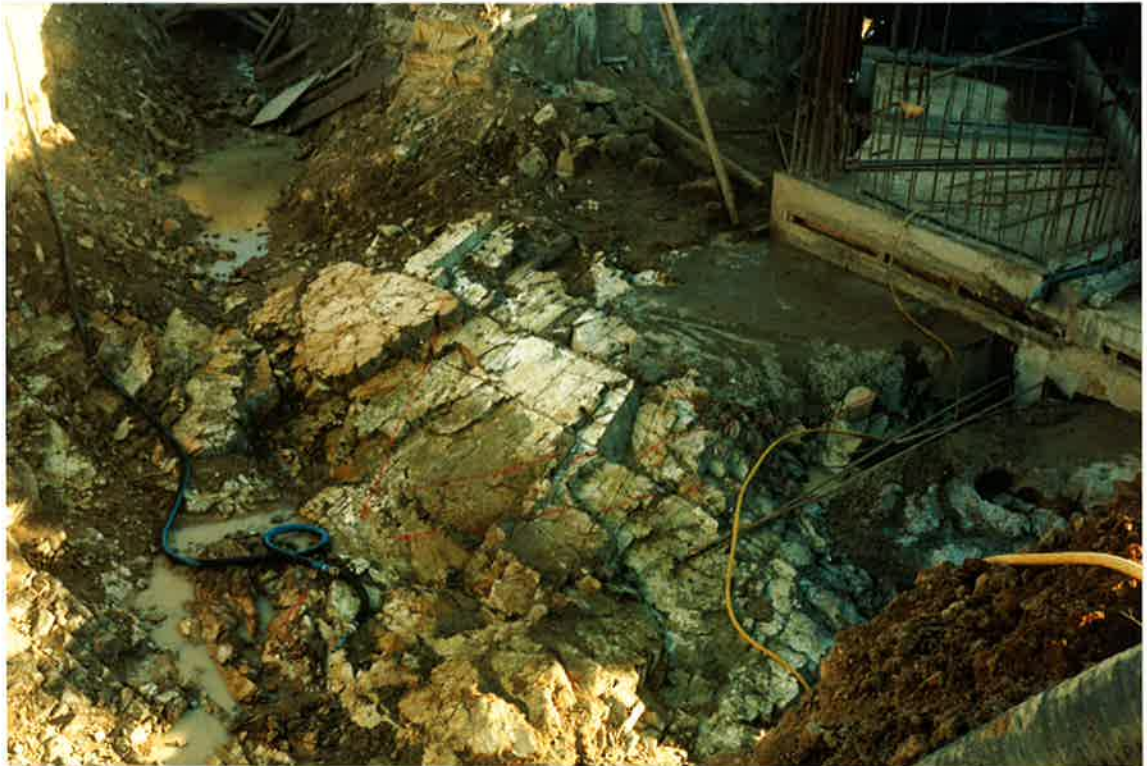
PHOTOGRAPH 12 Southern Abutment, showing large gently dipping joints, view south. May, 1987

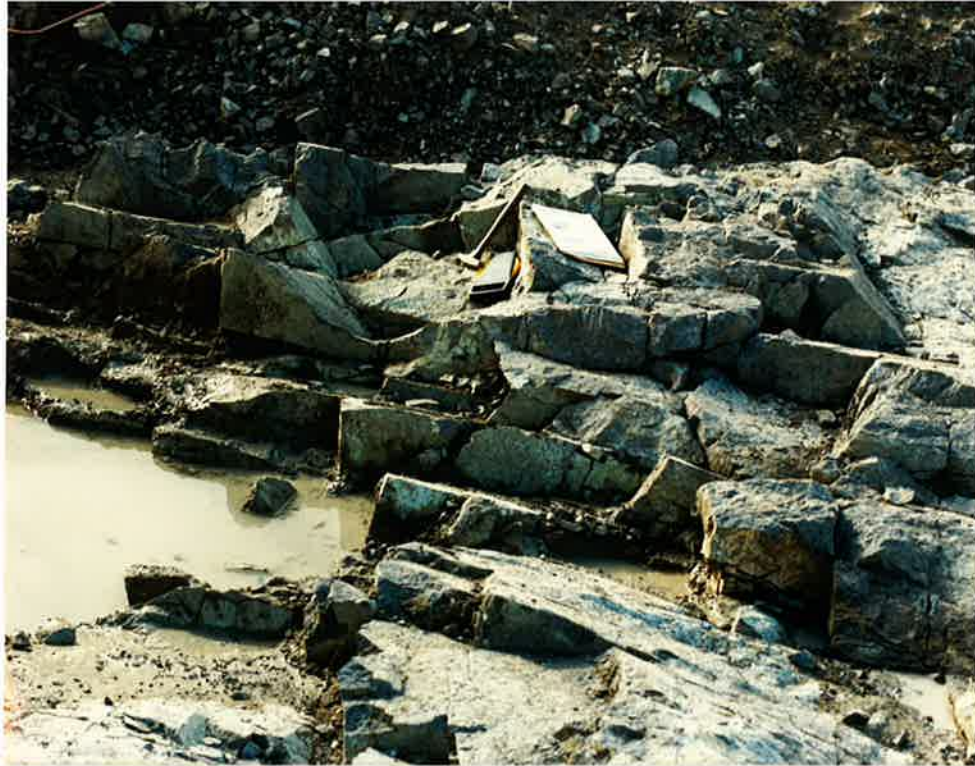
PHOTOGRAPH 14 Central Channel, west side, detail of shallow dipping joints. July, 1987
