Stage 2 Geotechnical Investigation Report

City Renewal Authority

Reference: 754-CBRGE334891-R02

B.2 : SITE 3 – GLEBE PARK

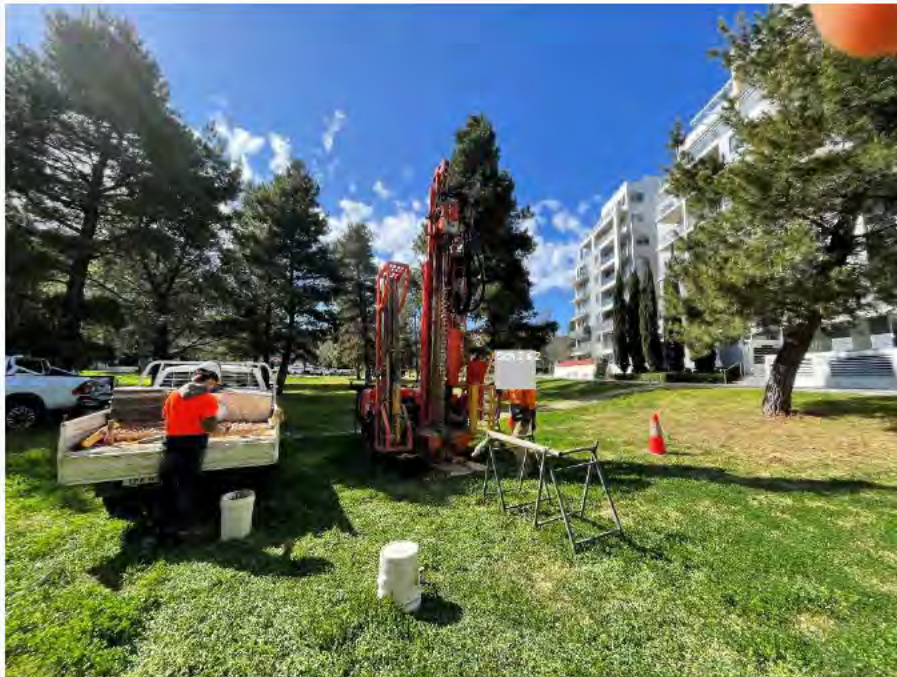
Photo 1 – Drilling at BH23, looking towards north east.

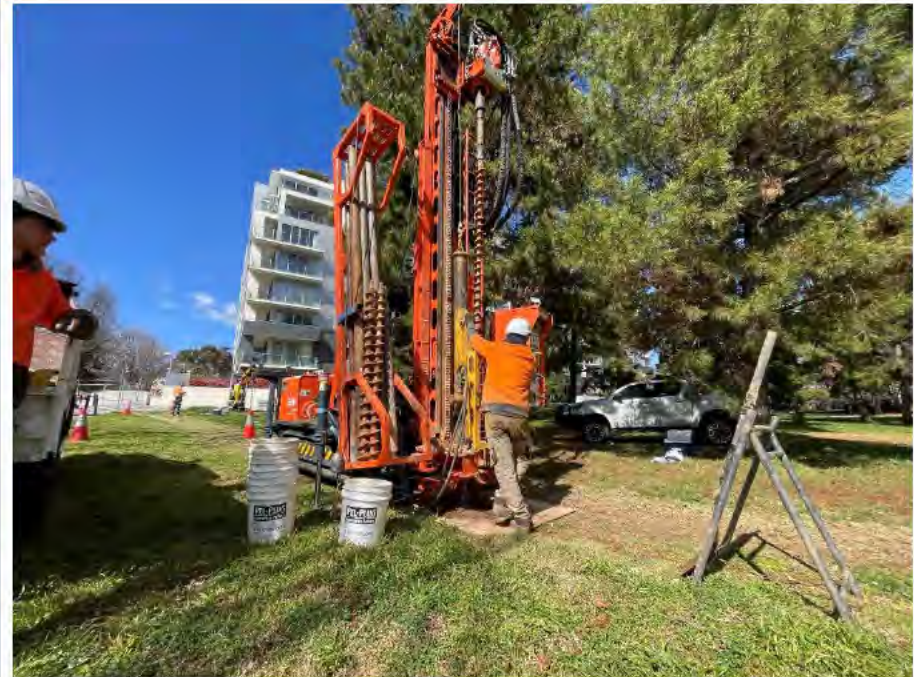
Photo 2 – Drilling at BH24, looking towards south.

Groundwater inflow was observed at BH24 and BH25 at 4.8m bgl and 2.7m bgl, respectively during auger drilling on 30 August 2024. It should be noted that groundwater may fluctuate in response to variations in rainfall, temperature and other climatic factors.

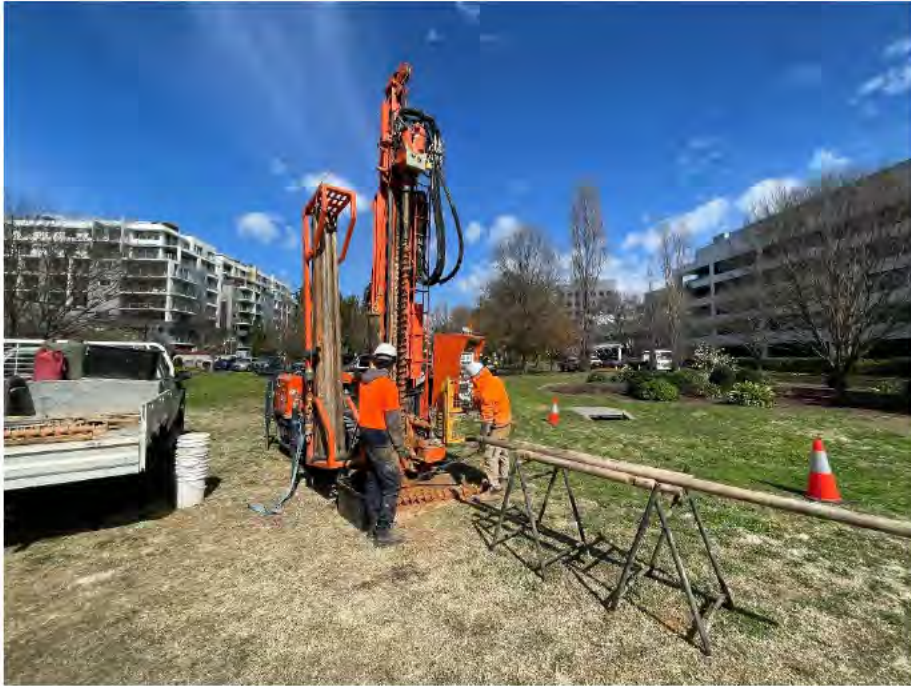
Photo 3 – Drilling at BH25, looking towards south west.

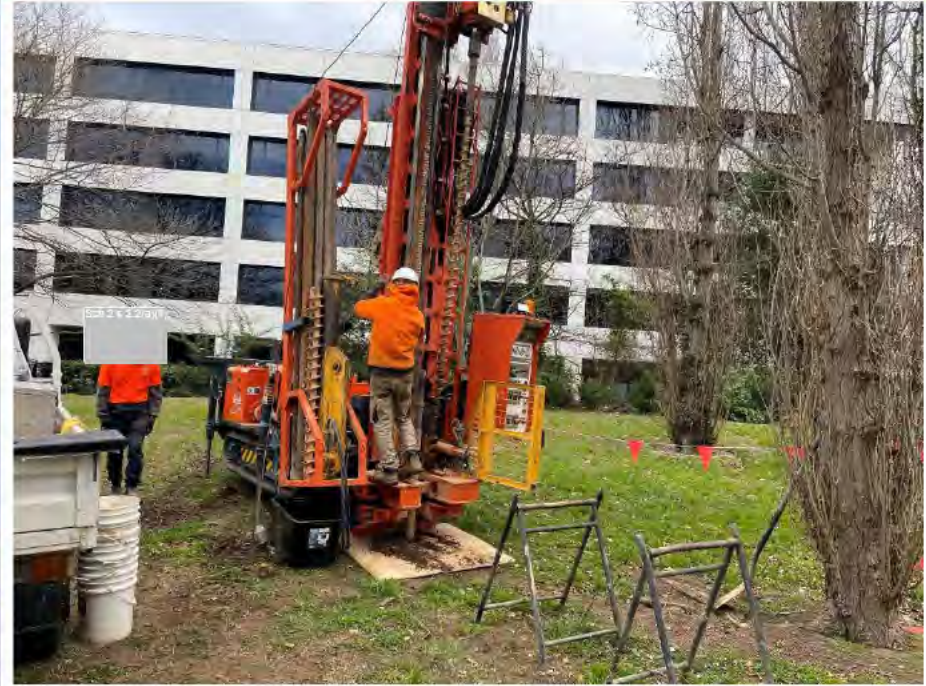
Photo 4 – Drilling at BH26, looking towards north west.

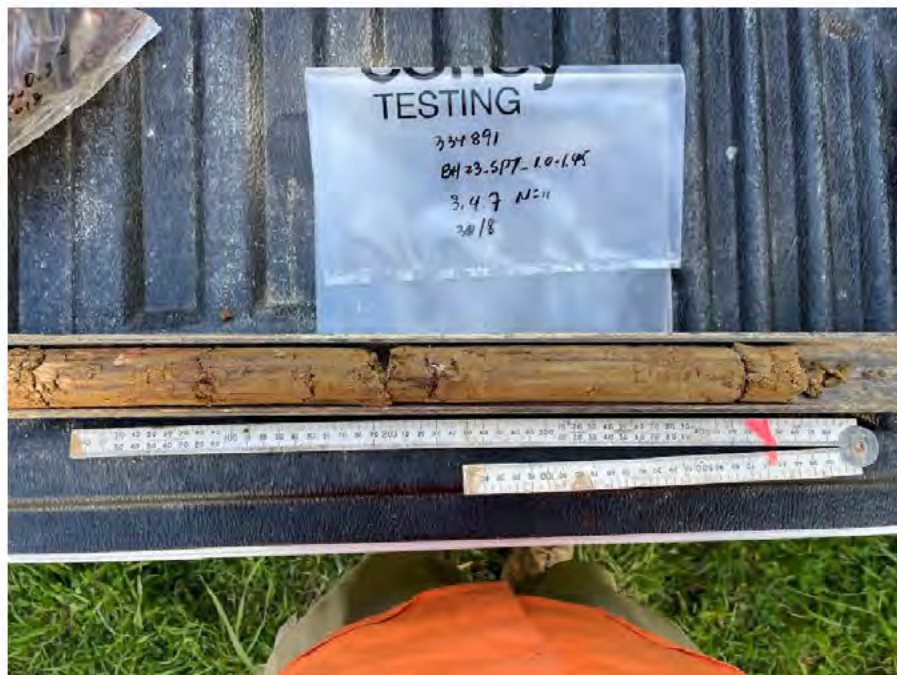
Photo 5 – SPT sample from BH23 at depth between 1.0 – 1.45m bgl.

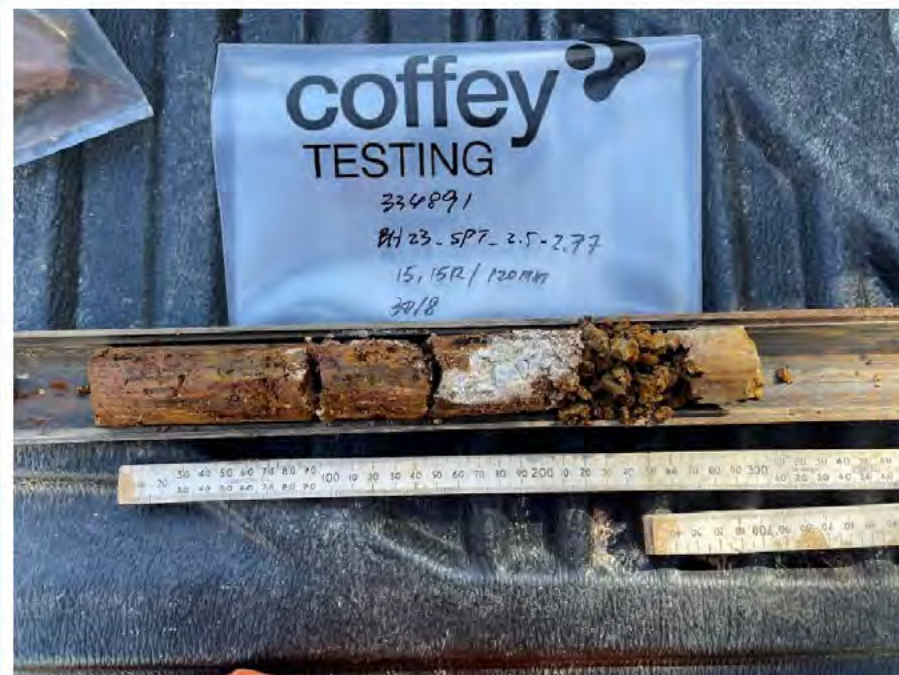
Photo 6 – SPT sample from BH23 at depth between 2.5 – 2.77m bgl.

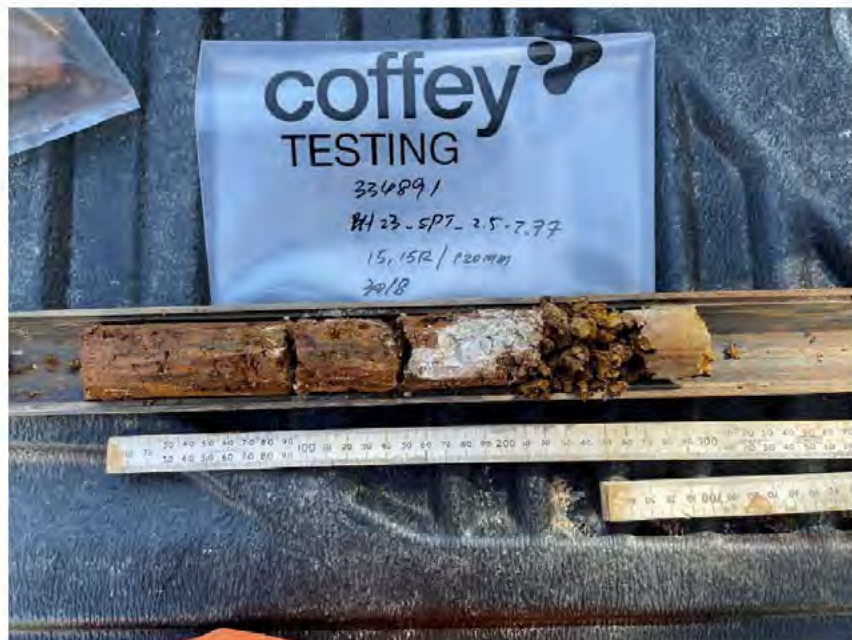
Photo 7 – SPT sample from BH23 at depth between 2.5 – 2.77m bgl.

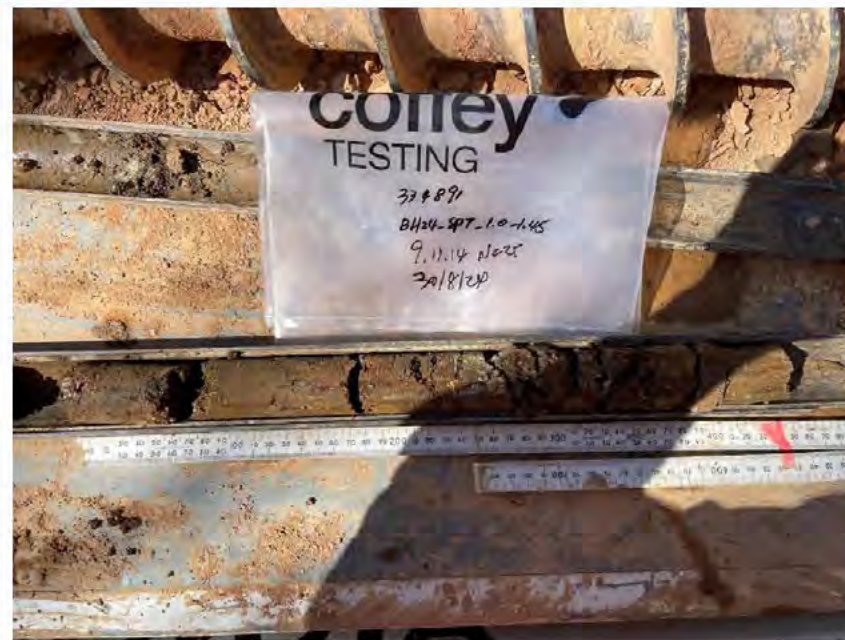
Photo 8 – SPT sample from BH24 at depth between 1.0 – 1.45m bgl.

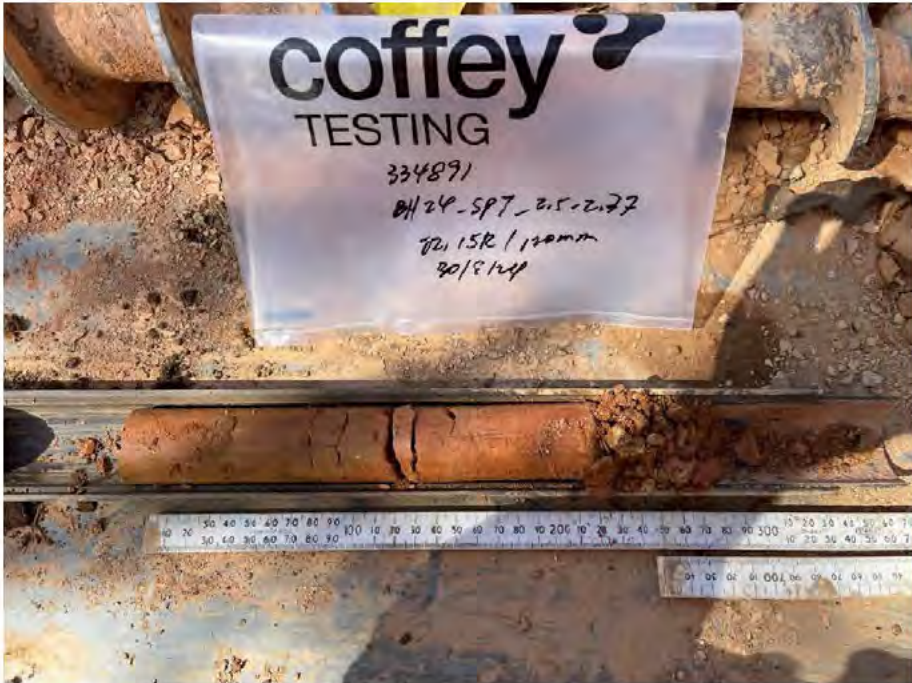
Photo 9 – SPT sample from BH24 at depth between 2.5 – 2.77m bgl

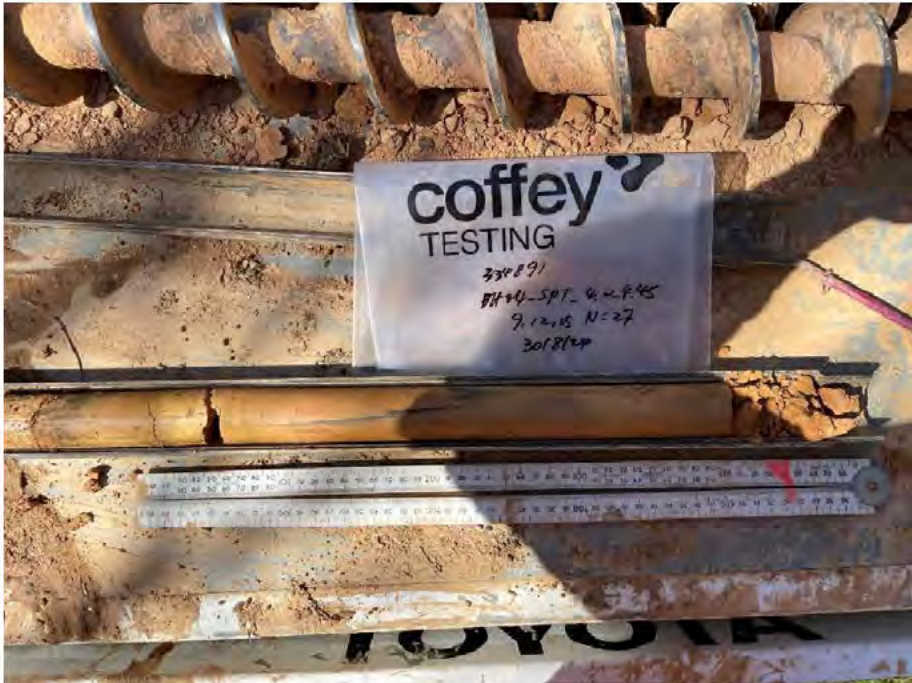
Photo 10 – SPT sample from BH24 at depth between 4.0 – 4.45m bgl

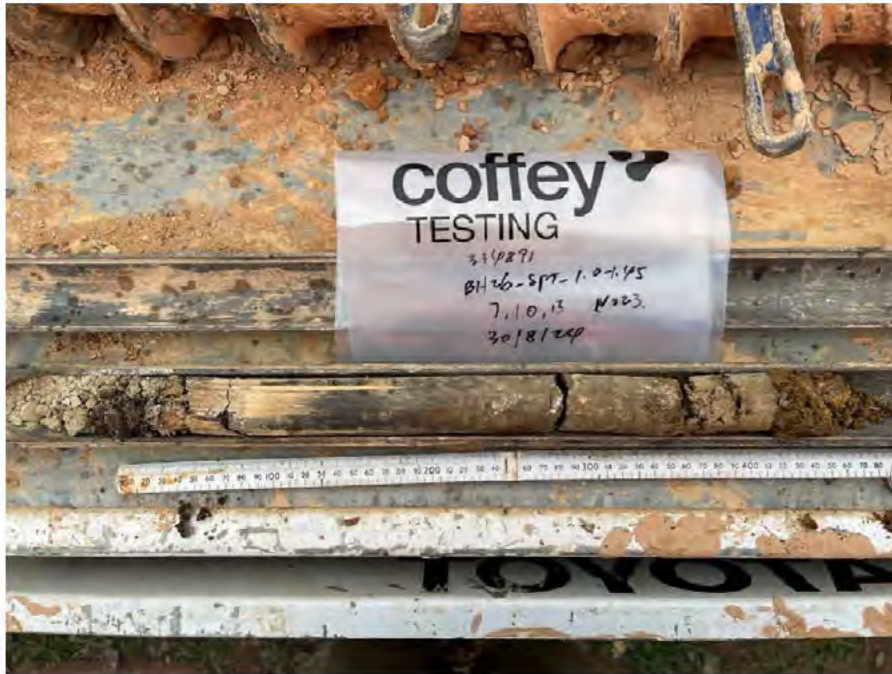
Photo 11 – SPT sample from BH26 at depth between 1.0 – 1.45m bgl.

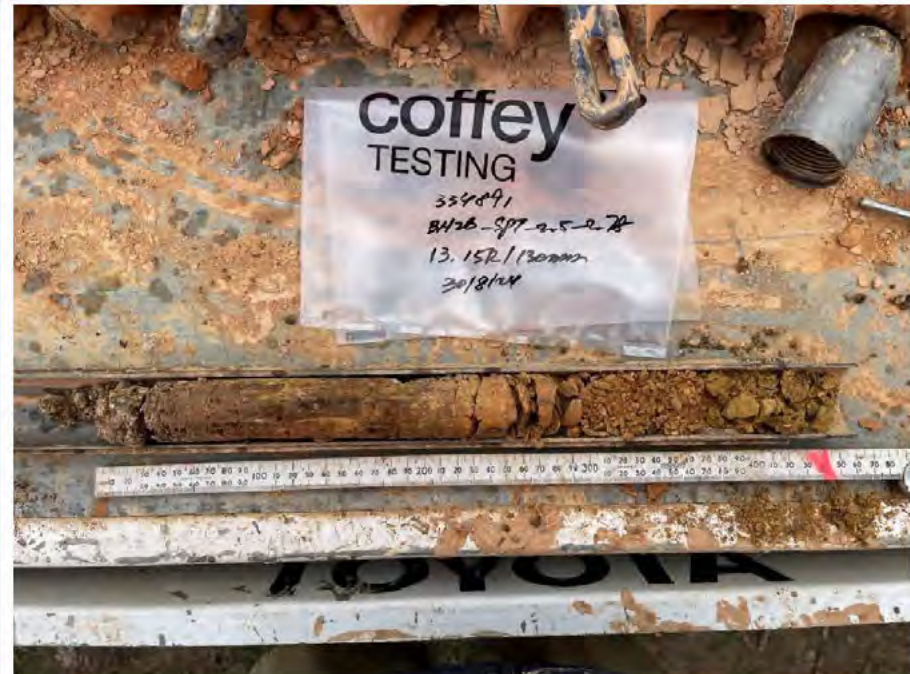
Photo 12 – SPT sample from BH26 at depth between 2.5 – 2.78m bgl.

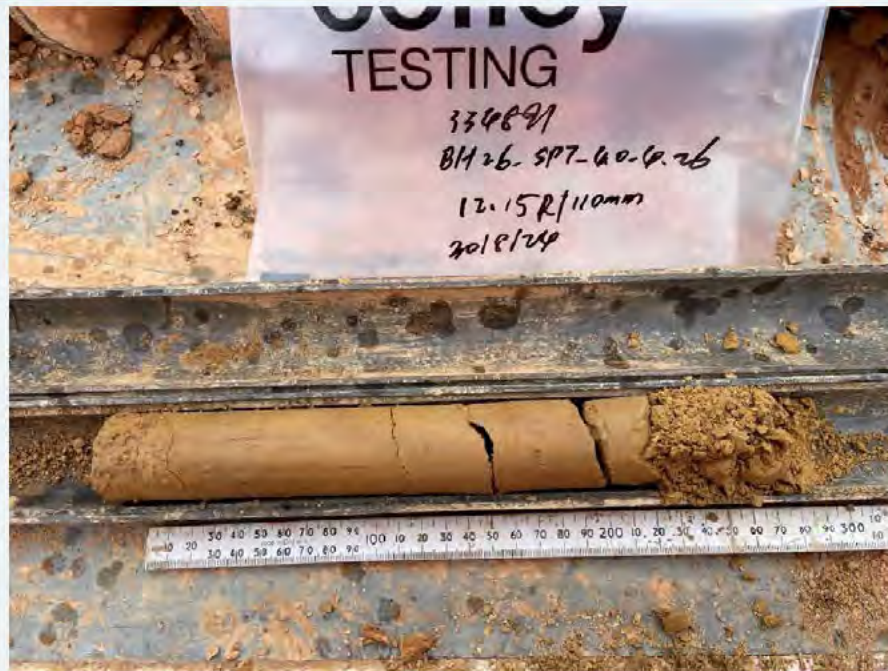
Photo 13 – SPT sample from BH26 at depth between 4.0 – 4.26m bgl.

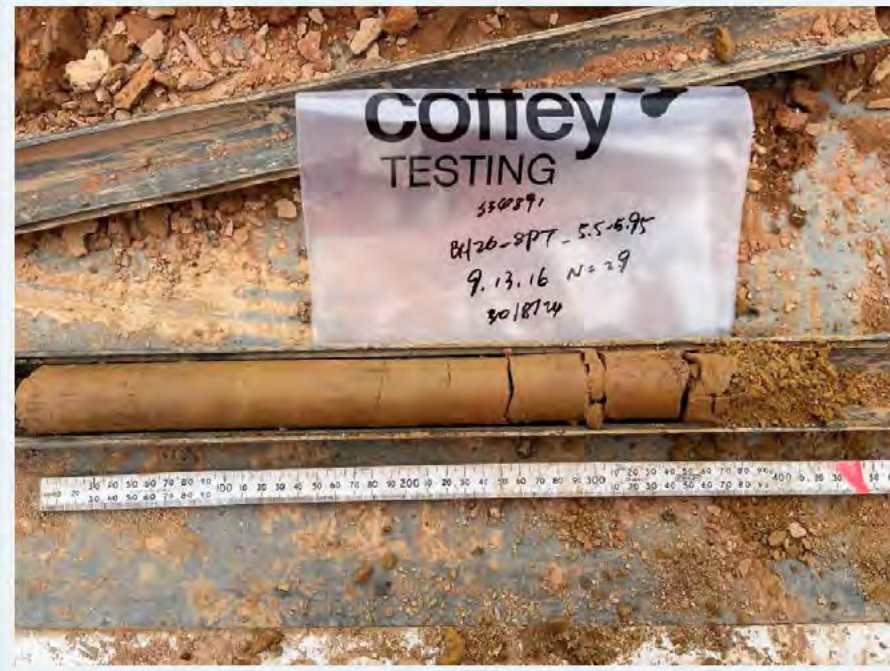
Photo 14 – SPT sample from BH26 at depth between 5.5 – 5.95m bgl.

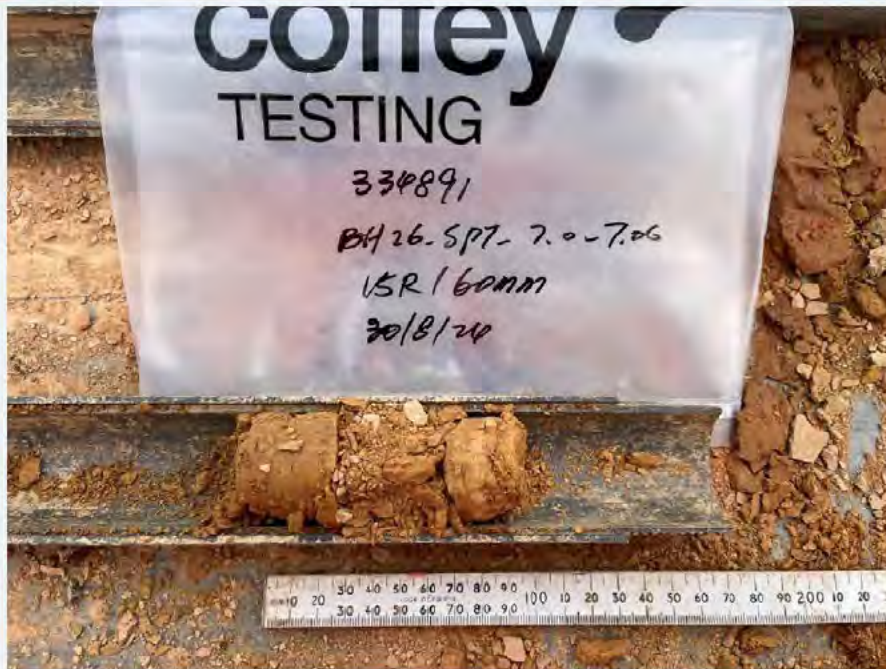
Photo 15 – SPT sample from BH26 at depth between 7.0 – 7.06m bgl.

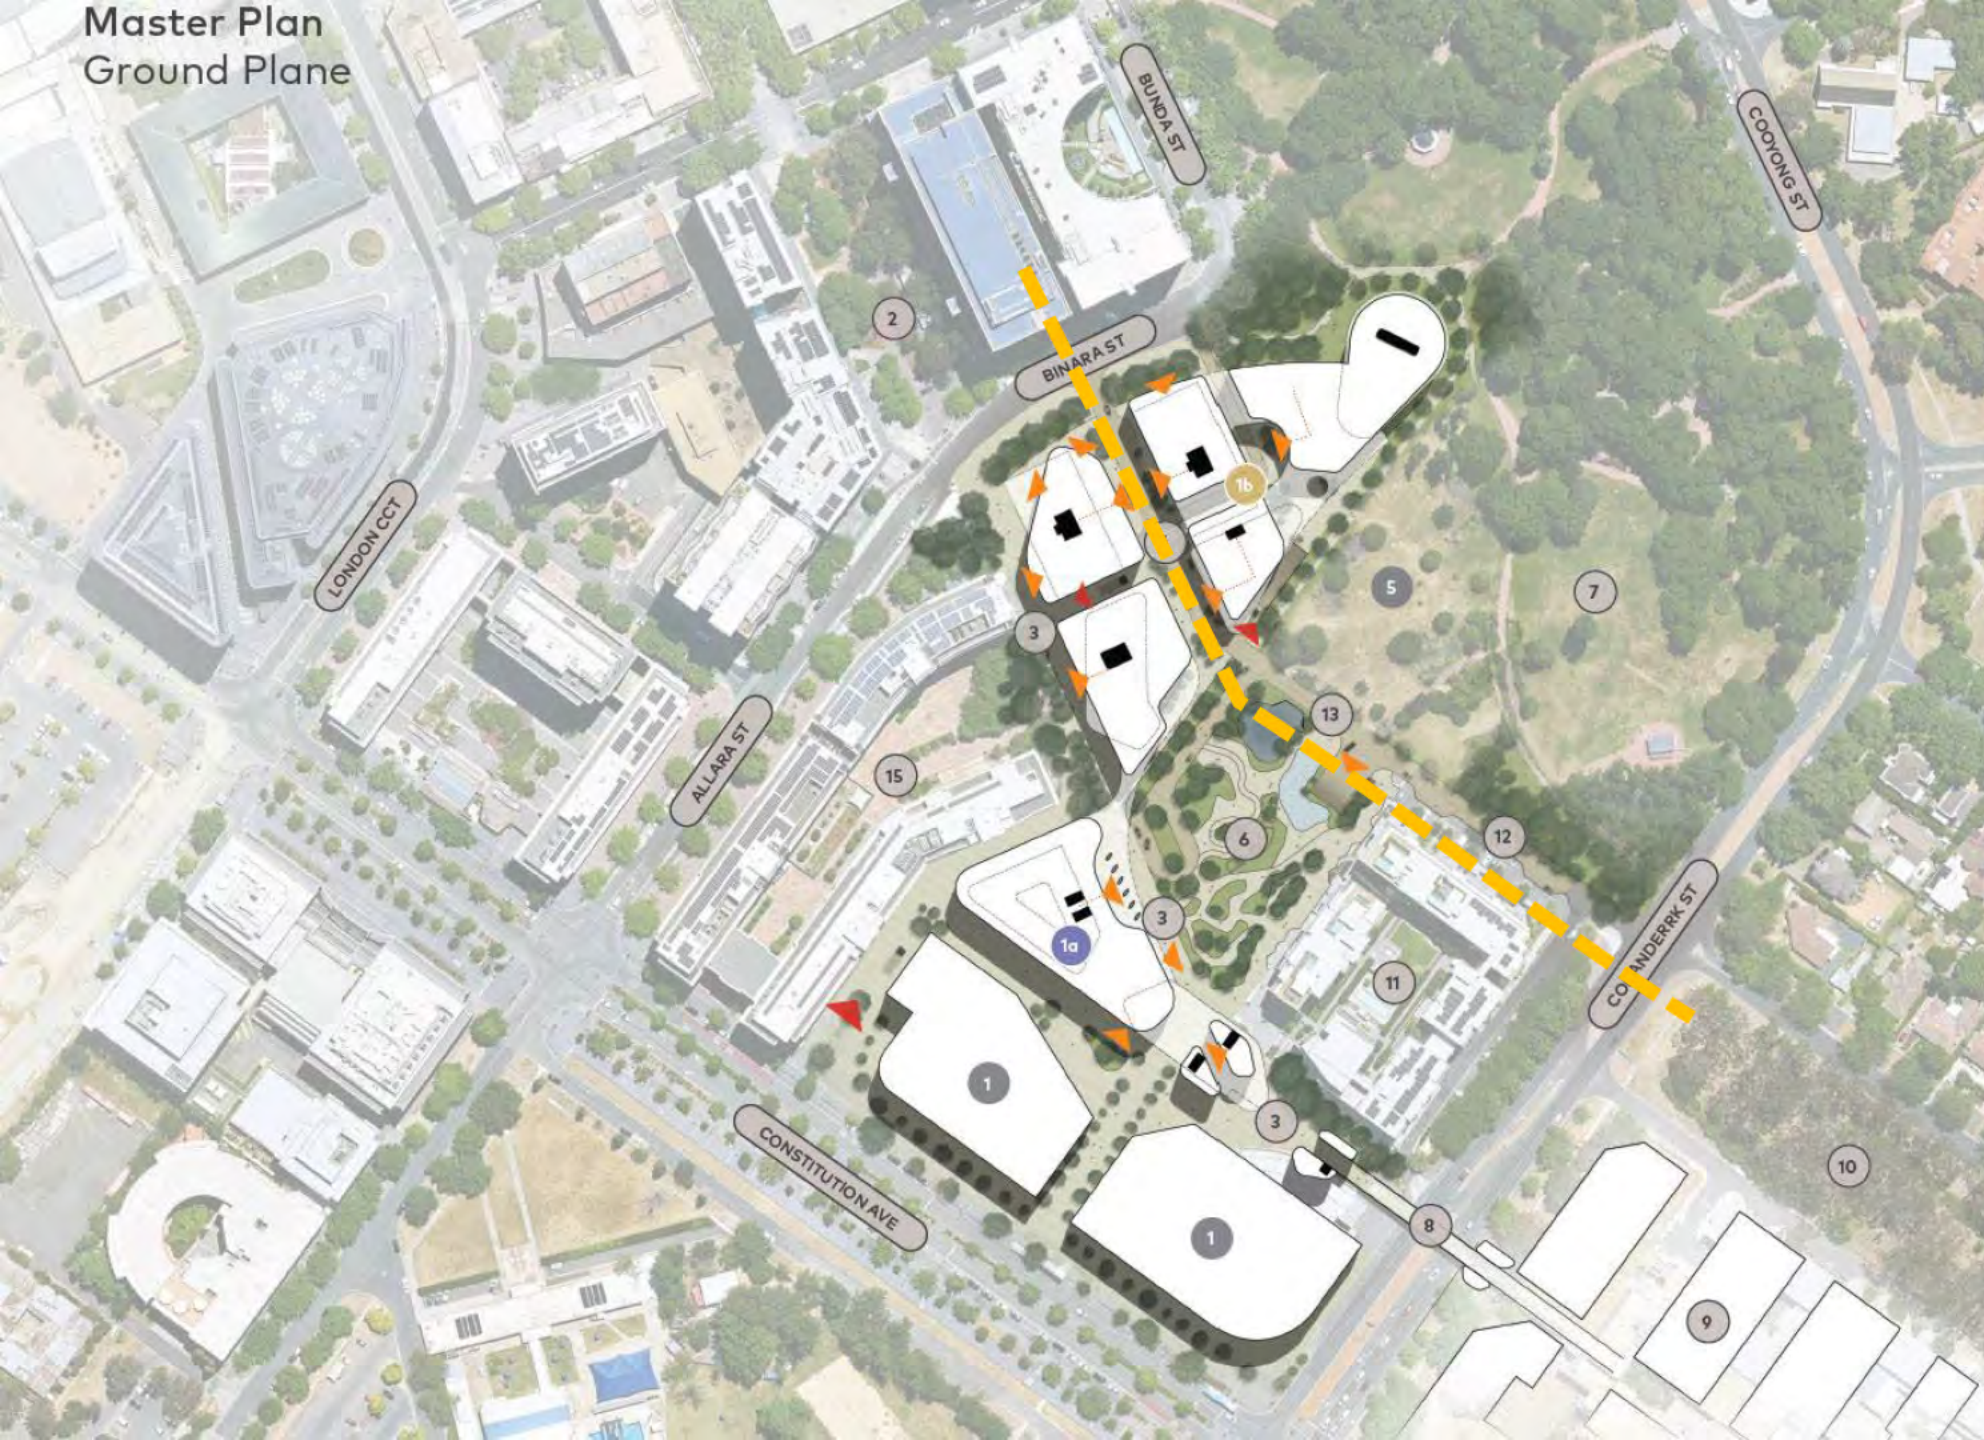
Master Plan Ground Plane

LEGEND	
1a	Block 16, Section 65- Canberra Casino
1b	Block 21, Section 65- Crown Plaza
	Entry Points
	Servicing
1	Block 14, Section 65 – Possible Future Development
2	City Walk
3	Proposed City Walk Extension
4	Proposed Shared Way
5	TBC
6	Block 24, Section 65 South – Parkland with Basement parking
7	Glebe Park
8	City Walk Footbridge to UNSW
9	Block 12, Section 33 – UNSW Campus future Masterplan
10	Railway Easement – UNSW Masterplan
11	Block 25, Section 65- Glebe Park Apartments
12	Glebe Park Apartments right of way easement
13	Proposed Opportunity for existing access extension
15	Block 9/10/12, Section 65- Allara St Offices
