FREEDOM OF INFORMATION REQUEST

18.	96 – 105	Draft TCCS Technical Note Urbos Frame Cracking	November 2021	Full		Y
19.	106	Email Correspondence	18 November 2021	Full		Y
20.	107-110	Draft Question Time Brief	17 November 2021	Full		Y

22.	111 – 112	Canberra Metro Operations: Sydney LRV Cracking Issues Key Messages	Undated	Full		Y
23.	113 – 122	TCCS Technical Note Urbos Frame Cracking	November 2021	Full		Y

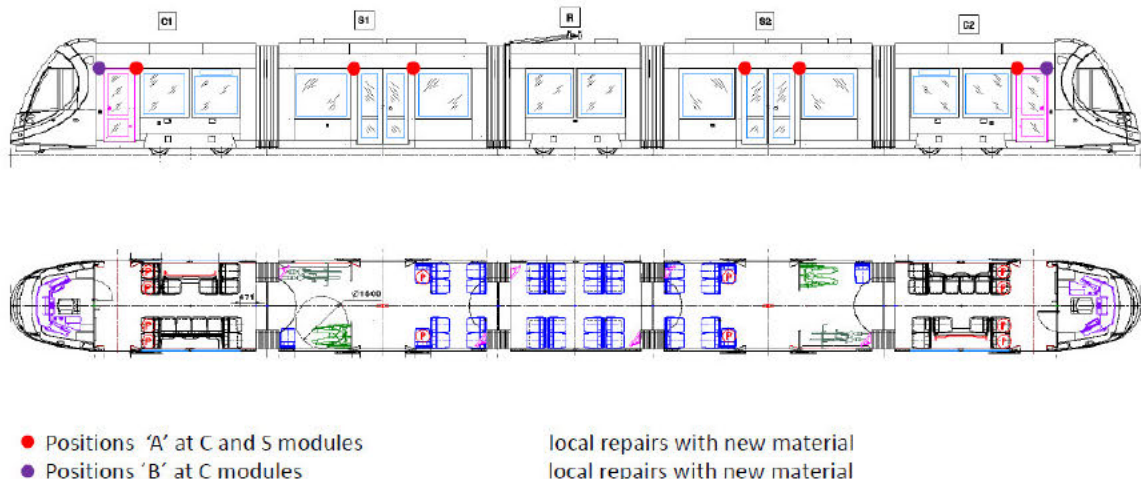
The final modification, as presented during previous communications, is shown on pages 21-26 of the document “Q56-Canberra_2019.02.06 videoconf final version”.

This solution will be implemented in all the areas exposed to fatigue failure.

Validation of the modification:

In one year's time, after the reparation has been completed, the whole fleet will be re-inspected to confirm the solution has been effective.

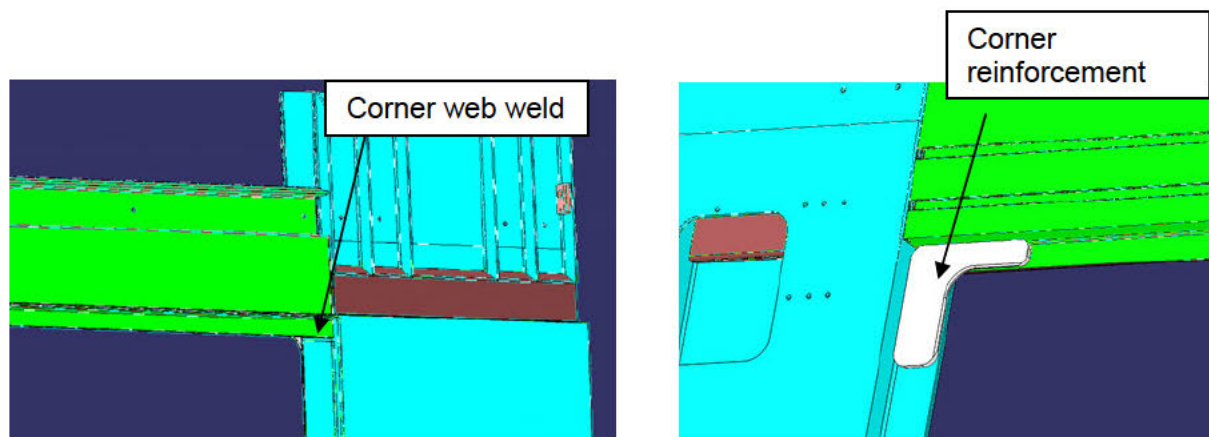
Figure 1 – Upper corners scope of this procedure

This procedure applies to the upper corners of door portals of S and C modules.

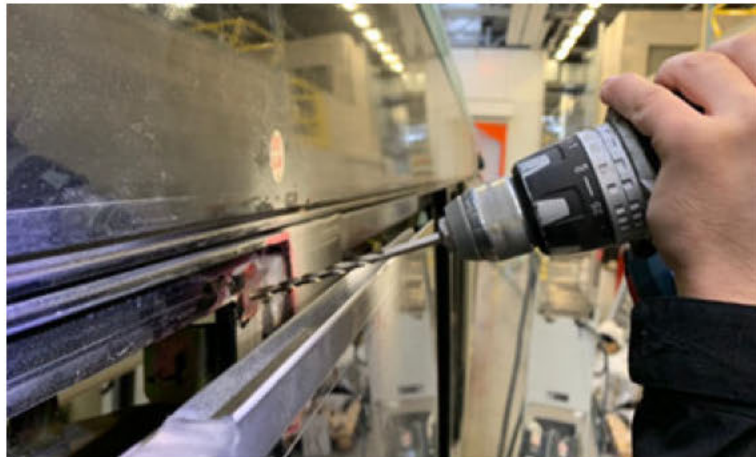
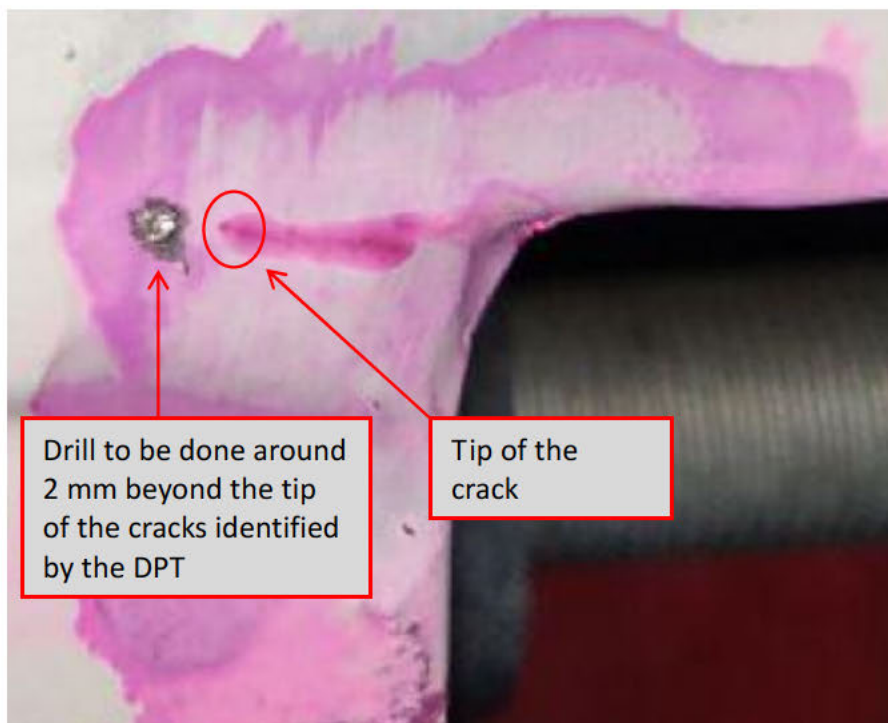
Figure 10 Drilling application

Drill to be done around
2 mm beyond the tip
of the cracks identified
by the DPT

Tip of the
crack

- Using the 6 mm drill, drill a hole around 2 mm beyond the tip of the cracks identified by the DPT. The drill should be done **as much perpendicular as possible to the surface (the drill will be necessary in a tilted position to avoid any interference with the door leaf)**.

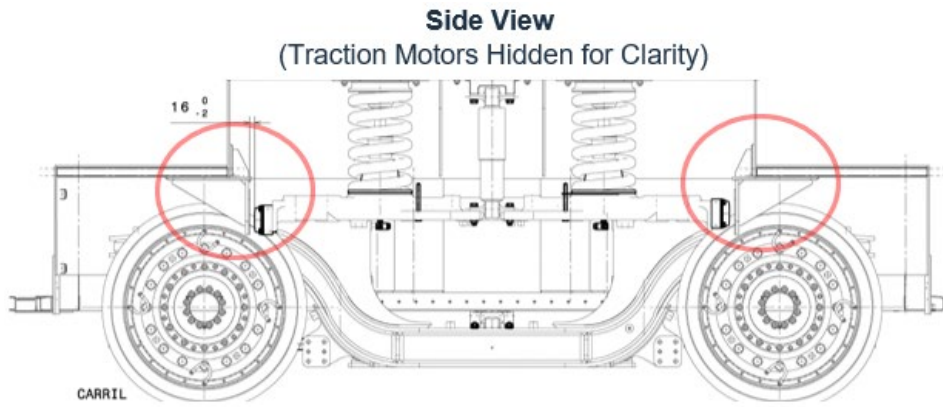
Figure 1: Bogie rotational bracket (bump stop) on traction motor bogie

At this stage it was thought the cracking was limited to these bump stops and on 5 November 2021 Canberra Metro advised TCLR that they *“do not foresee cracking of the bump stops to occur on the Canberra LRV fleet”* and, in summary:

- Canberra has a different bump stop design,
- The specific maintenance checks carried out on the Canberra fleet confirm tolerances which were out in IWLR are not out in Canberra, and
- An operational check is to be put in place by CMET.

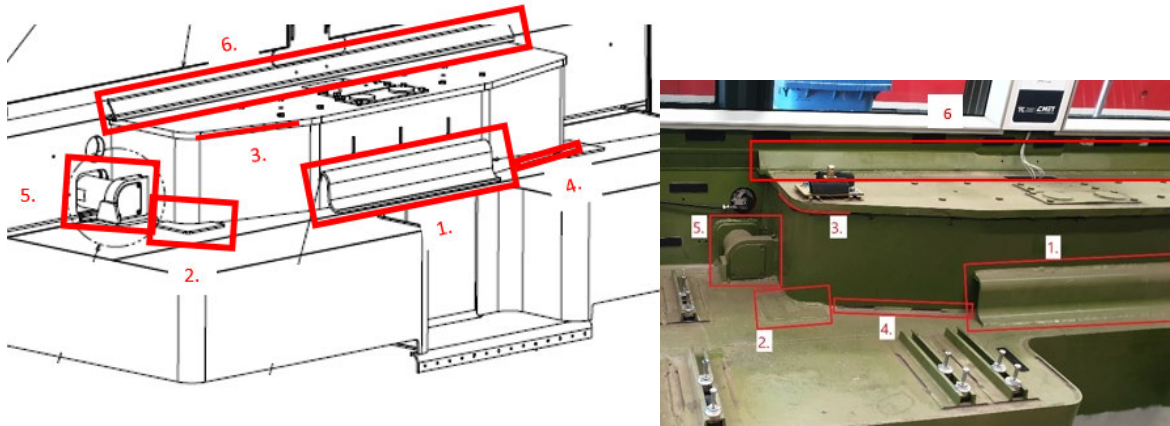
Figure 10: Annotated image of bogie box – Canberra Light Rail

These are all visible and annotated in Figure 9 and Figure 10, below.

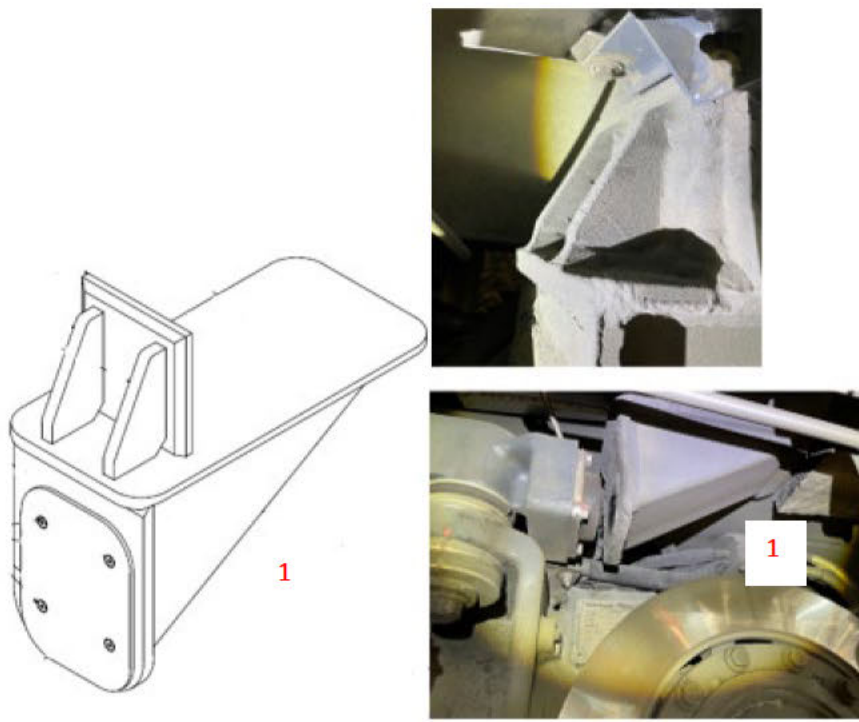
Figure 12: Annotated image of bump stop – Canberra Light Rail

1. The size and shape of the bump stop on the Canberra Light Rail provides a more robust design with a larger triangular wedge.

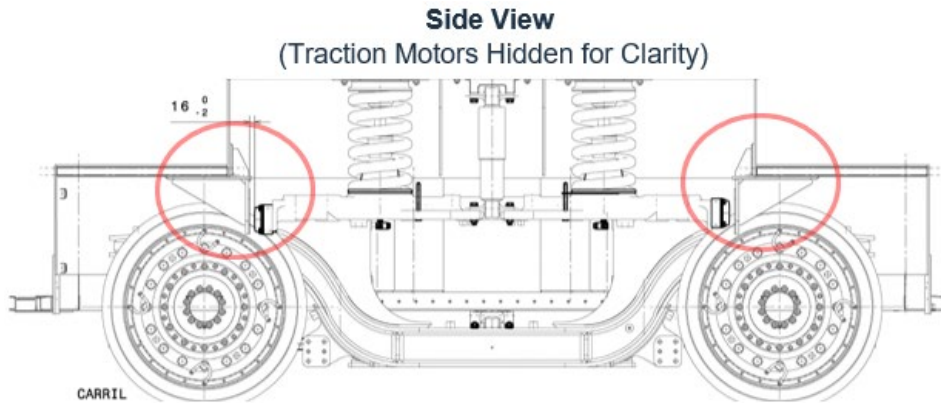
Figure 1: Bogie rotational bracket (bump stop) on traction motor bogie

At this stage it was thought the cracking was limited to these bump stops and on 5 November 2021 Canberra Metro advised TCLR that they *"do not foresee cracking of the bump stops to occur on the Canberra LRV fleet"* and, *"in summary:*

- *Canberra has a different bump stop design,*
- *The specific maintenance checks carried out on the Canberra fleet confirm tolerances which were out in IWLR are not out in Canberra, and*
- *An operational check is to be put in place by CMET”.*

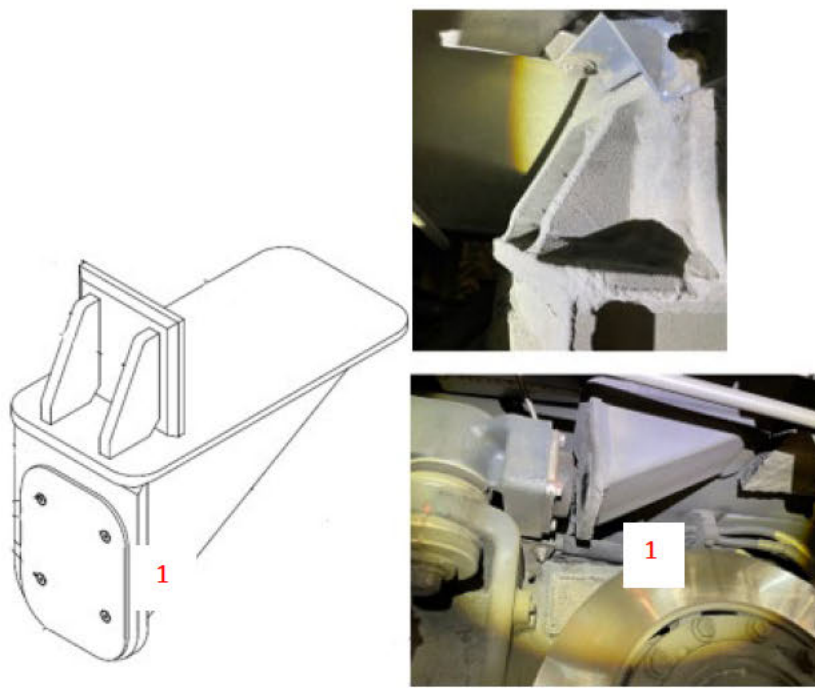
Figure 12: Annotated image of bump stop – Canberra Light Rail

1. The size and shape of the bump stop on the Canberra Light Rail provides a more robust design with a larger triangular wedge.
